# Using Integrated Surveillance Technology to Improve Wildlife Strike Reporting, Response and Mitigation

**Sara Handrigan**, Client Services Coordinator, Accipiter Radar

**Steve Osmeck**, Airport Wildlife Biologist, Port of Seattle

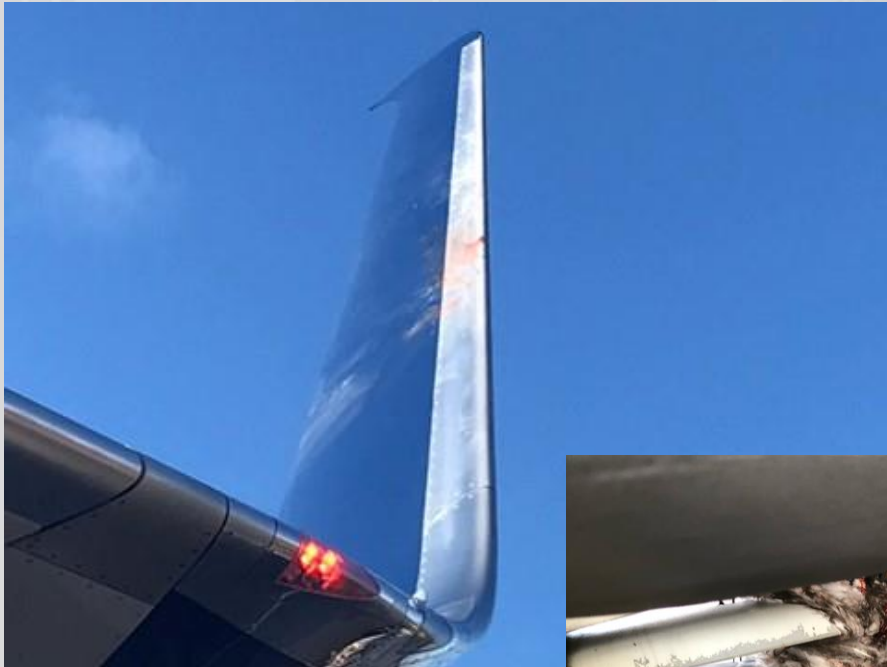
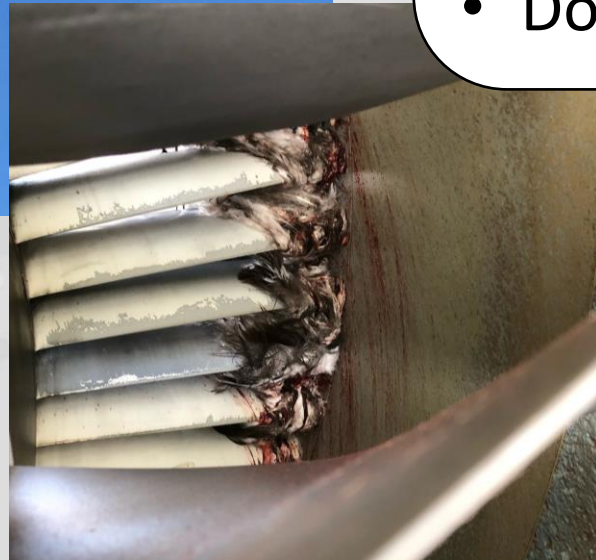
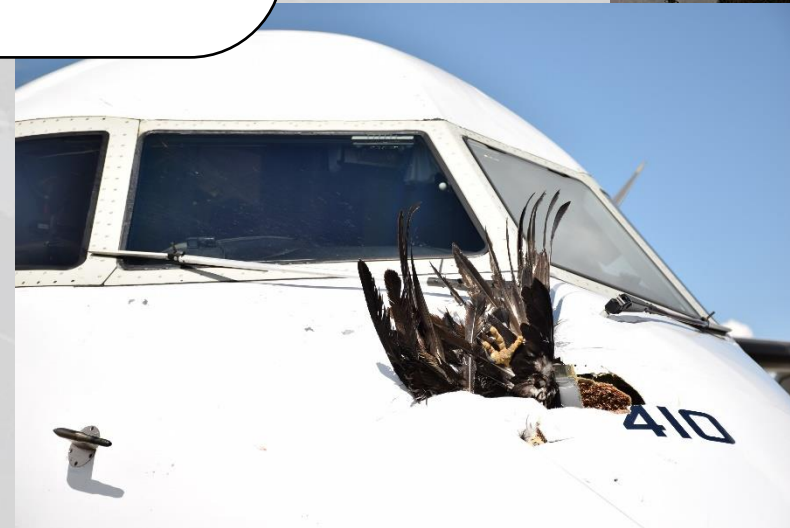
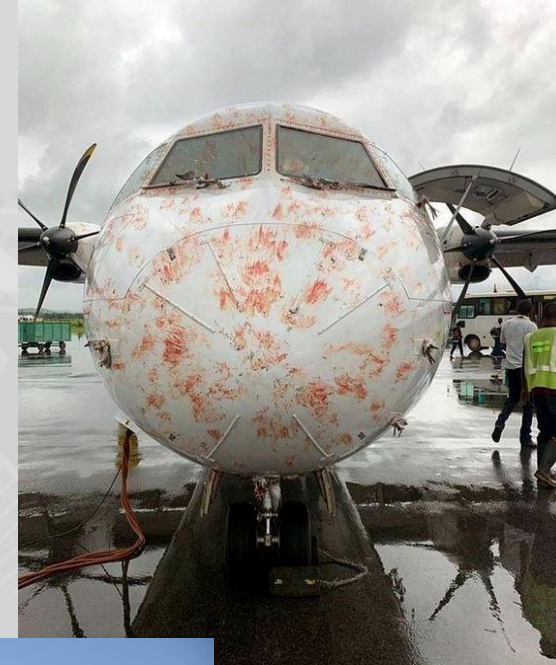
### Damage

- AC Part
- Severity
- Cost Estimate
- Downtime

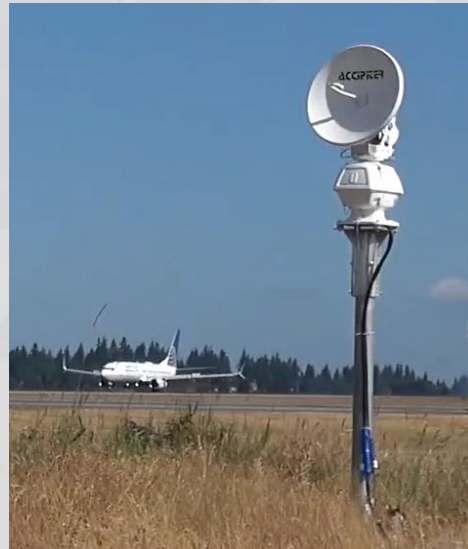
## Avian Radar System

- Detects moving targets on and off airport
- 3 radar units in operation
- Operates 24/7/365
- Alerts to persistent bird presence
- Capable of tracking the aircraft itself
- Data is retained forever to allow for historical analysis
- Detects birds at night when human visibility is limited

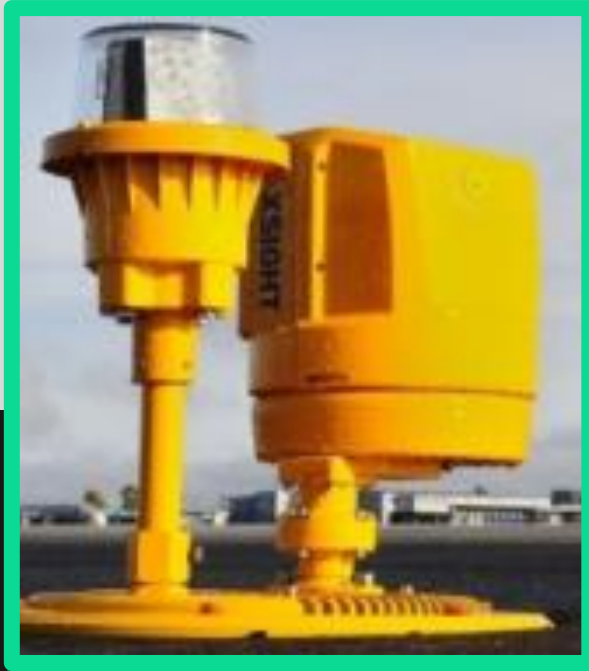
## Foreign Object Debris (FOD) Detection System

- 101 edge-light FOD sensors
- Operates 24/7/365 & radar 360 degrees
- Optical/infrared cameras take photos/video runway side only
- Biologists get unfiltered data...everything

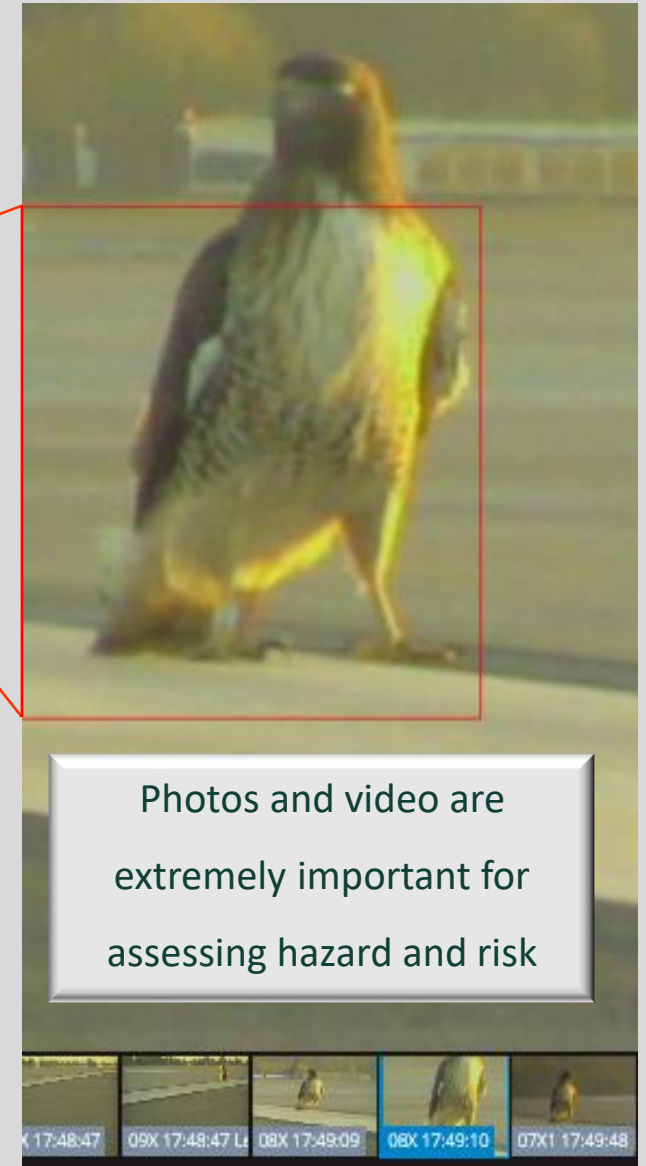
# FOD Detection System

- Date, time, location, size and images/videos stored indefinitely

- New strikes detected quickly
  - Communicated to flight crew fast

Photos and video are extremely important for assessing hazard and risk

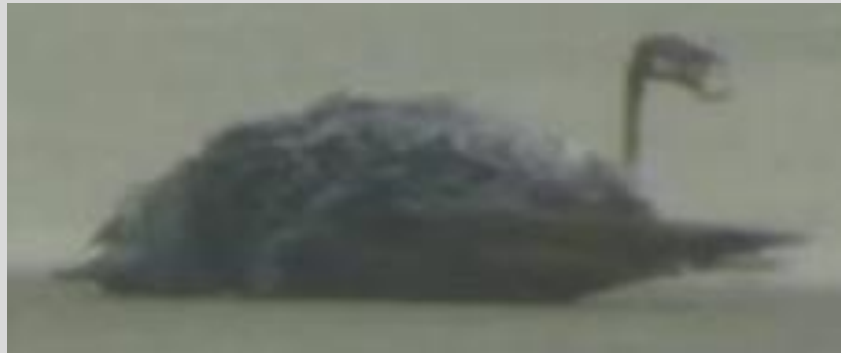
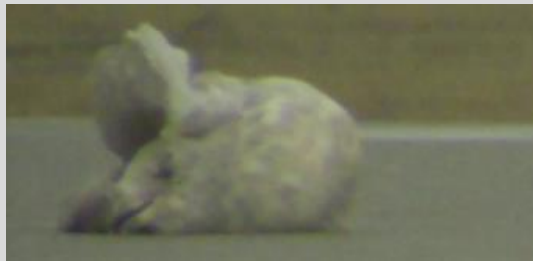
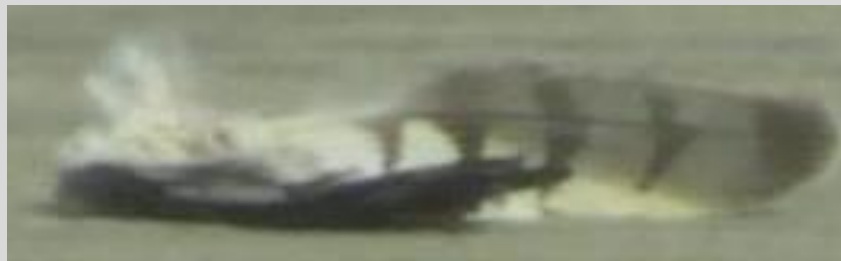
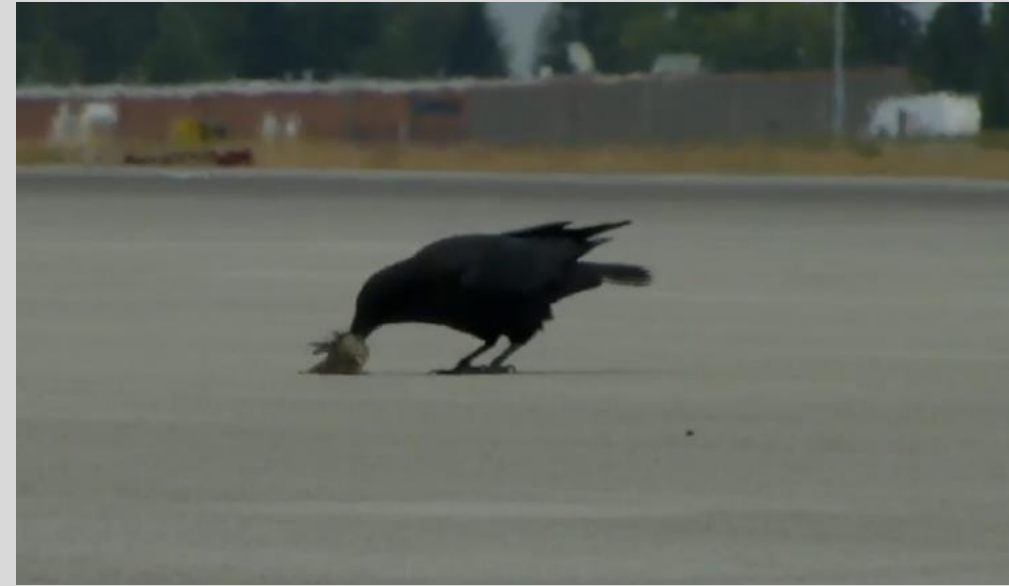
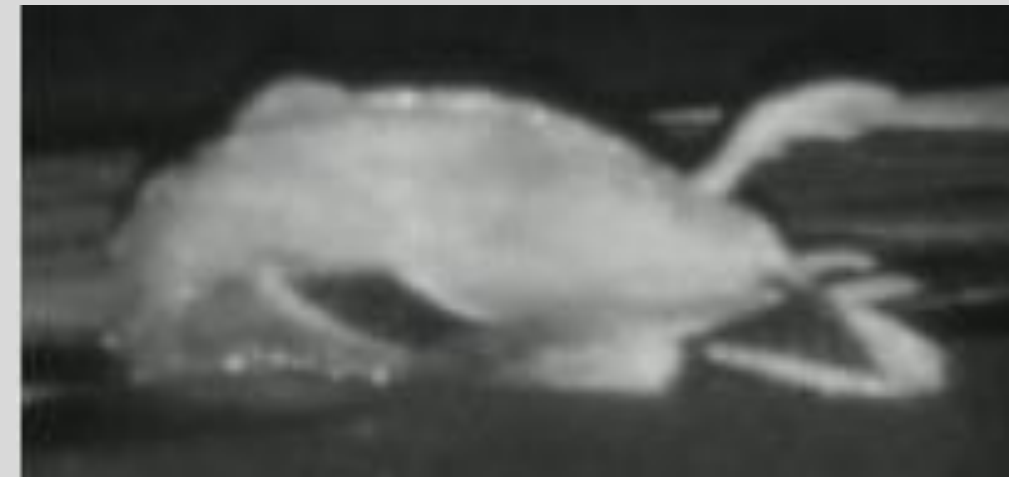
Strike time, location and photo obtained real-time

- Other benefits
  - Improved strike rate information (strikes commonly scavenged)
  - More wildlife hazard alerts and harassment
  - Locations of prey densities identified

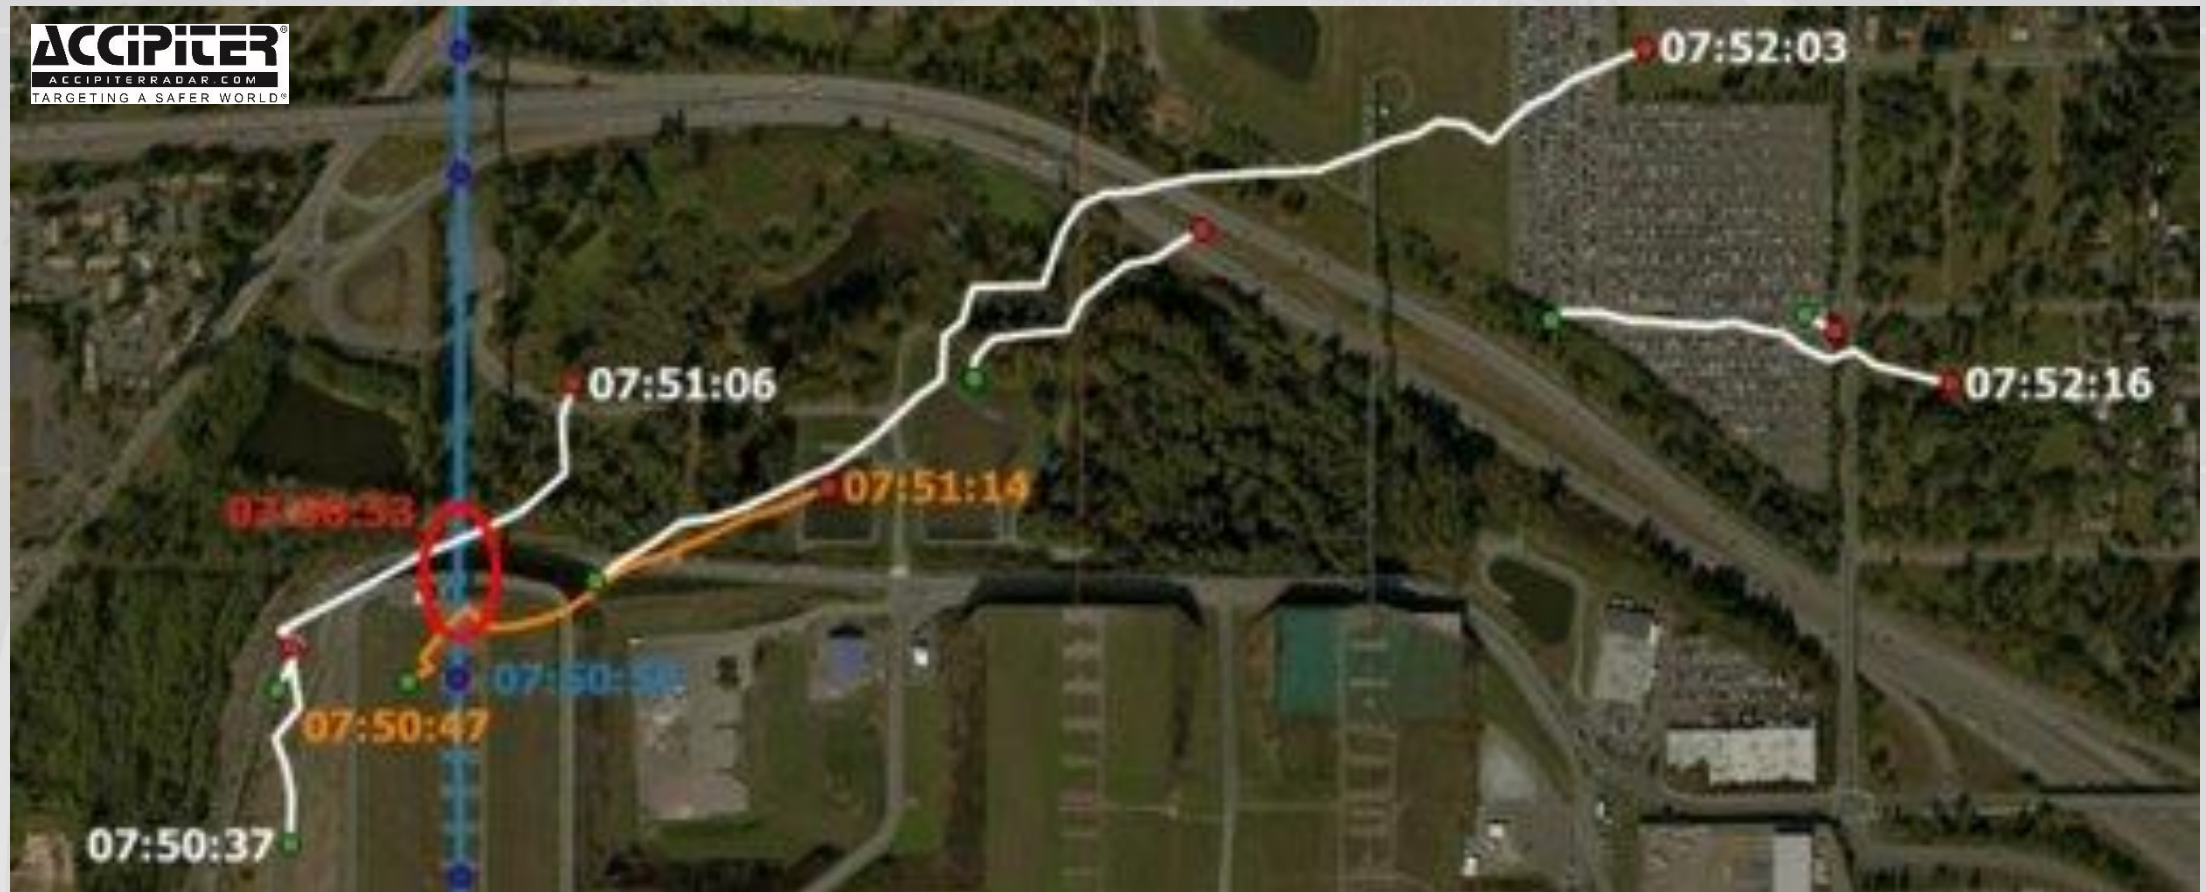
## Avian Radar Investigation

- Identified the location and precise time of the strike by looking at the intersection between avian radar tracks and ADS-B

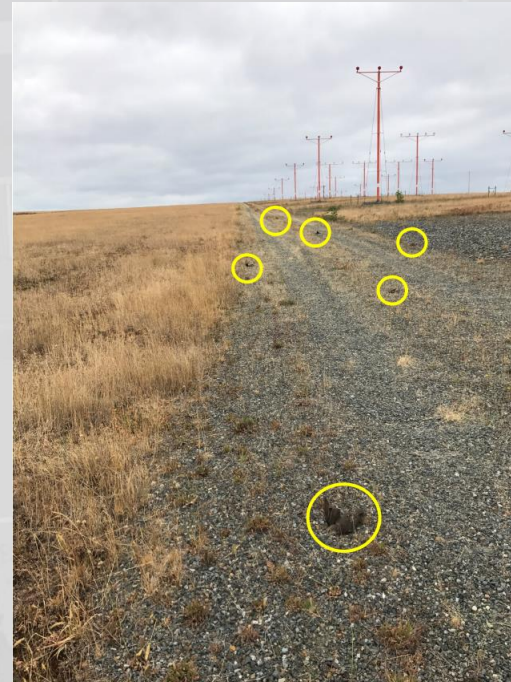
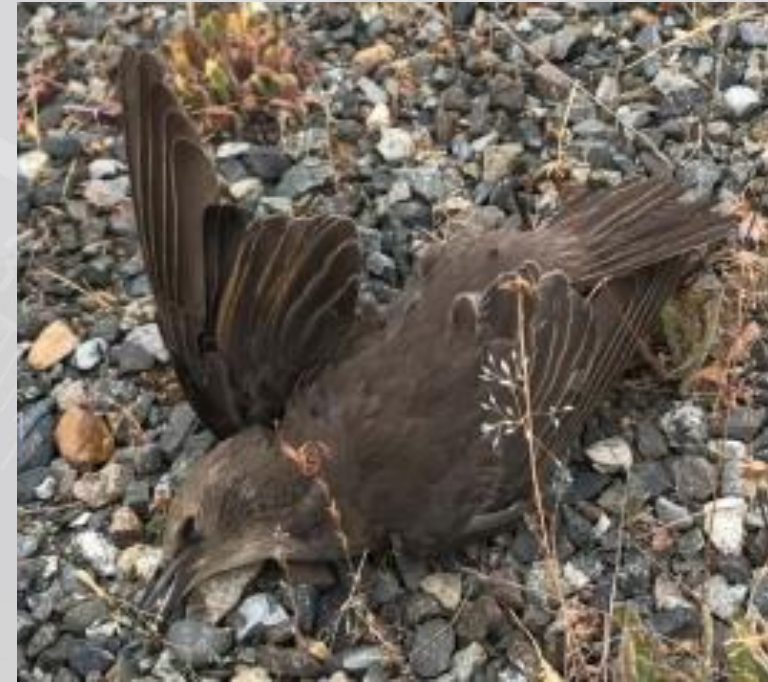
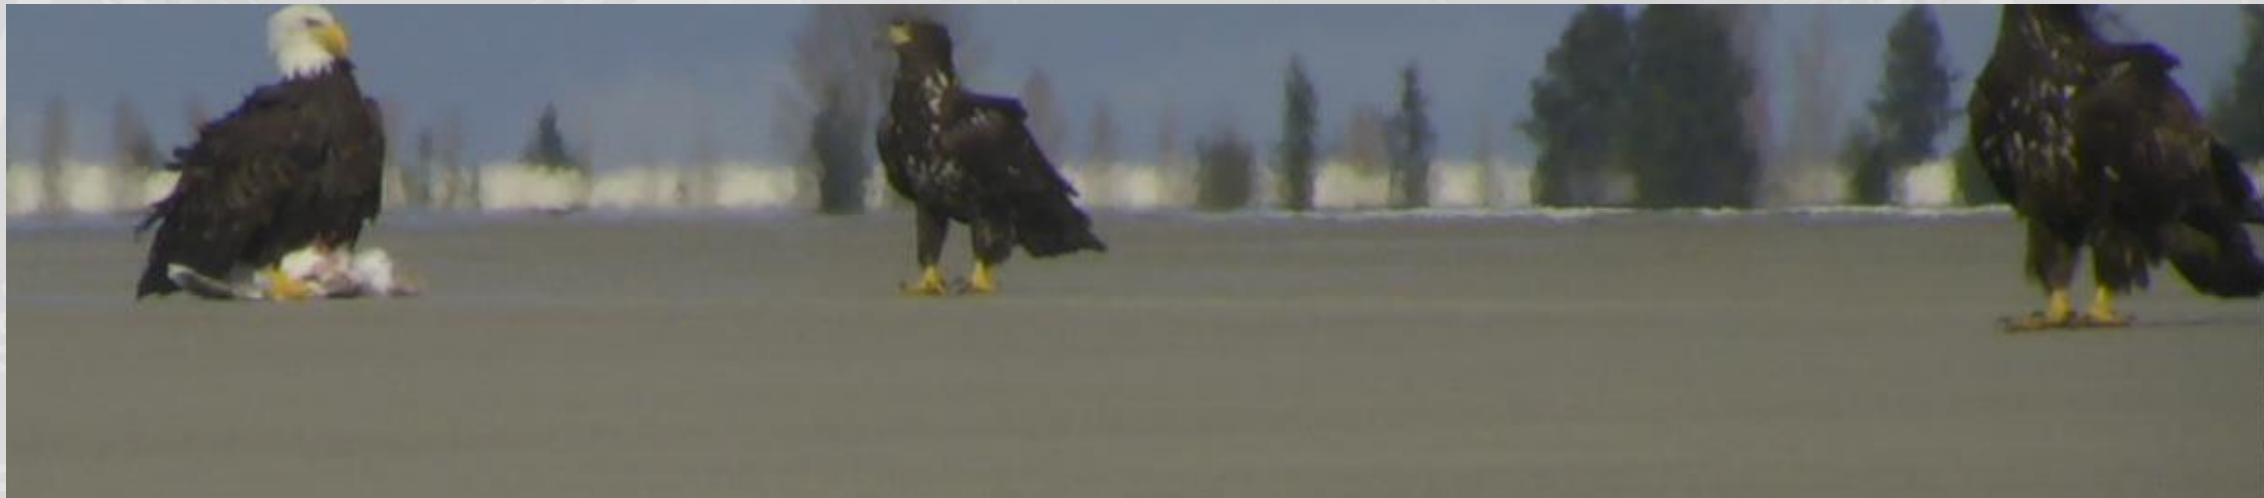
- Called ATCT
- Walked the site
- 10 European starling carcasses discovered

**Carcasses retrieved so they would not attract eagles**

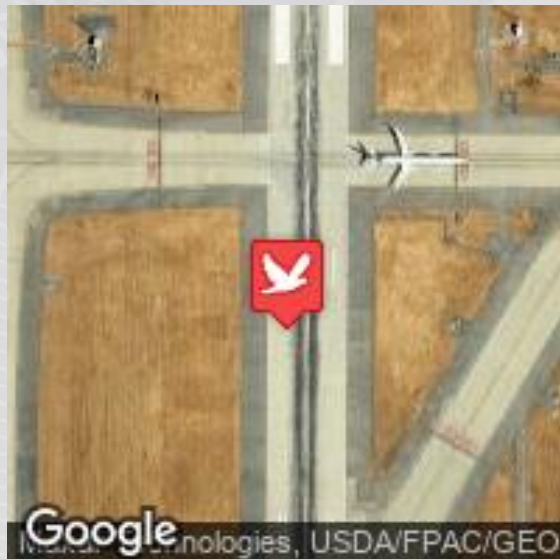
## 2023-11-13 Mallard Strike

- SEA staff were alerted to the presence of at least two carcasses on runway 34C using the FOD detection system
- Smithsonian confirmed ID as mallards
